OCTOBER 2022

Prepared for Steering Committee involving Glamorgan Spring Bay Council and Tasmania Parks and Wildlife Service

## ORFORD FORESHORE MASTER PLAN

Prepared for Glamorgan Spring Bay Council and Tasmanian Parks and Wildlife Service

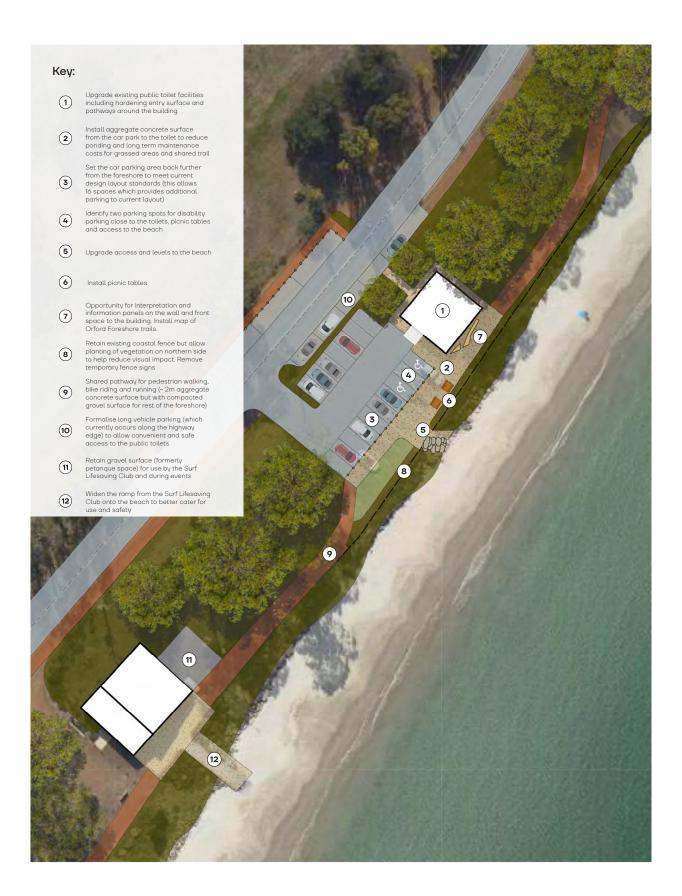
### **Map 3.4 Raspins Beach Conservation Area**

Toilet and Carpark Site Concept Plan

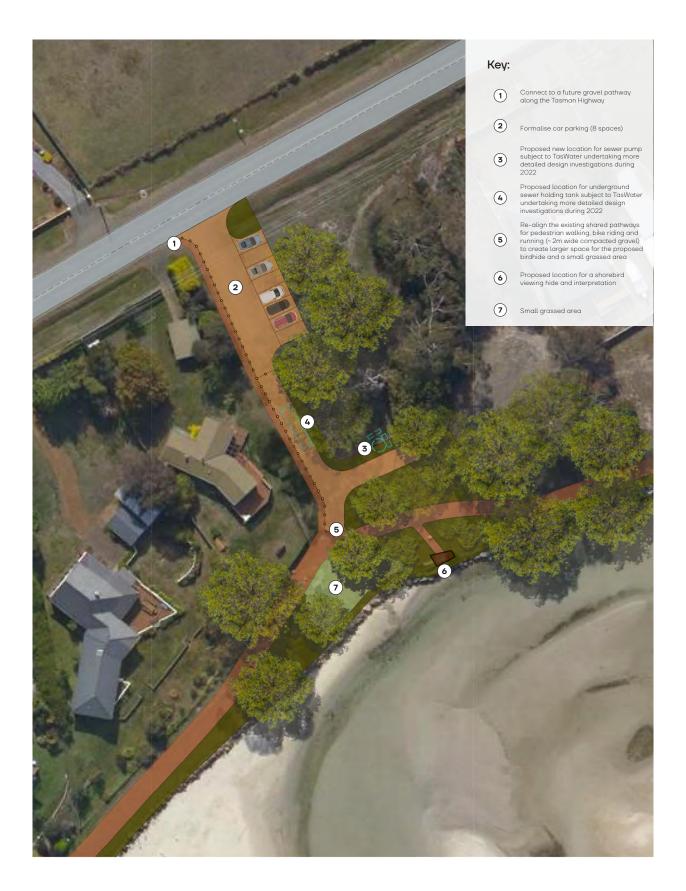
Map 3.5 Public Reserve-Radar Beach Site Concept Plan

The concept plan indicates that the overall amenity and use of the area could be enhanced by restricting public vehicle access to the foreshore with the provision of a designated parking area off the highway. A lockable bollard would allow management vehicles, including TasWater to access the foreshore as required.

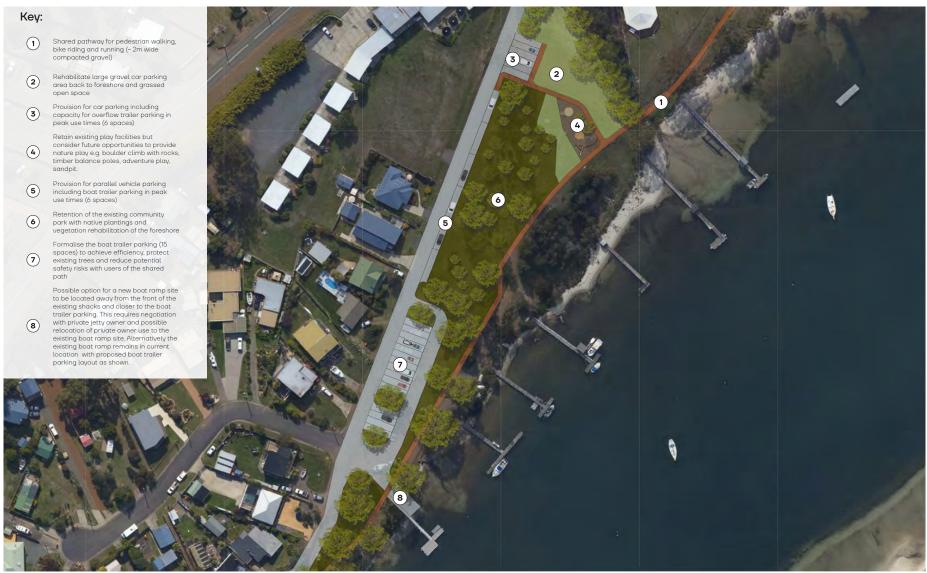
### Map 3.7 Prosser Boat Ramp Concept Plan

The boat ramp is the main boat launching facility for Orford and boating use has increased with the dredging and channelising of the Prosser River mouth. The boat ramp was located to take advantage of the deeper water at this site, but the narrow width of public land requires vehicle and trailer parking to occur

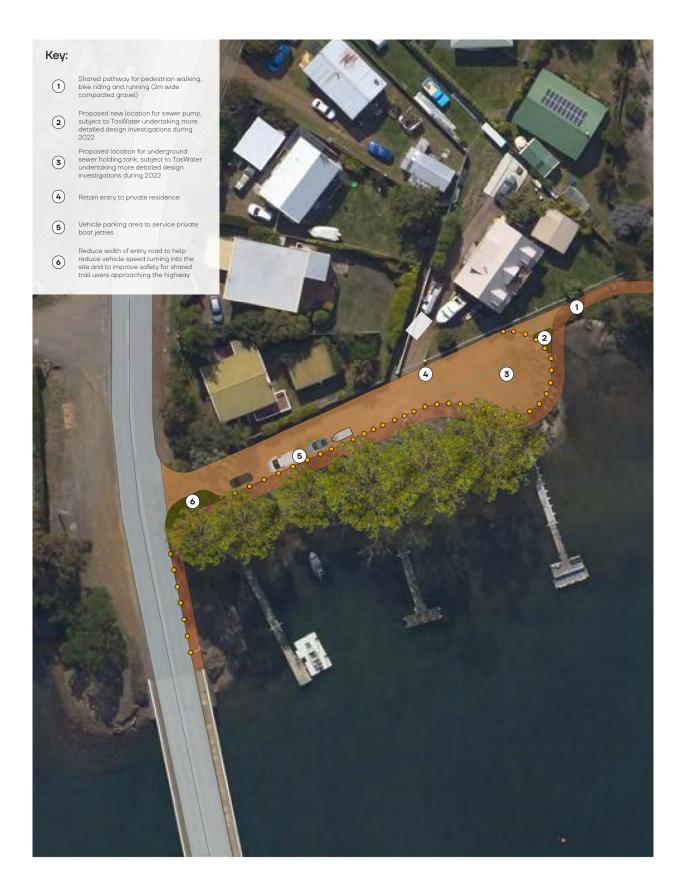
Map 3.8 Prosser Bridge Site Concept Plan

Prior to these suggested upgrades, Crown leases delegating land management responsibilities must be in place where required. Parcels of crown land where council have/wish to install infrastructure that also have jetty licences attached should be recreational licences.

No	Recommended Actions	Responsibility
M1	Prepare a management plan under the <i>Crown Lands Act</i> 1976 for the reserve incorporating the Orford Bird Sanctuary to clarify management priorities and address a range of issues and options.	PWS
M2	Implement proposed improvements at Radar Beach (refer to Map 3.5 Site Concept Plan) in conjunction with site works being undertaken by TasWater.	PWS, Council
M3	Implement proposed improvements at the site north of Prosser River (refer to Map 3.7 Site Concept Plan) in conjunction with site works being undertaken by TasWater.	PWS, Council
M4	Subject to funding, undertake major works and improvements at Raspins Beach (refer to Map 3.4 Site Concept Plan)	PWS, Council, State Growth
M5	Undertake works at Millingtons Beach to improve use and manage site impacts. Formalising the access road and car parking subject to funding (refer to Map 3.8 Site Concept Plan).	PWS and Council

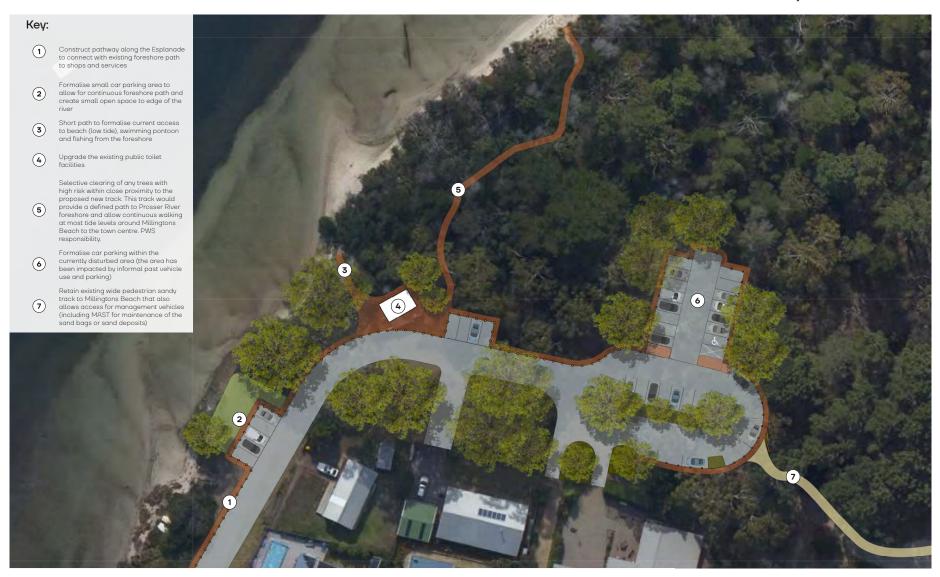
Map 3.9 Millingtons Beach Conservation Area Carpark Site Concept Plan

Prior to these suggested upgrades, Crown leases delegating land management responsibilities must be in place where required. The bike track where it passes over Millingtons should also be covered by a recreational licence.

Some of Council's infrastructure on the southern side of the Prosser Riverbank area is also located on the Millingtons Beach Conservation Area. This area includes the pedestrian pathway, parking and landscaping which should be covered by a recreational licence.

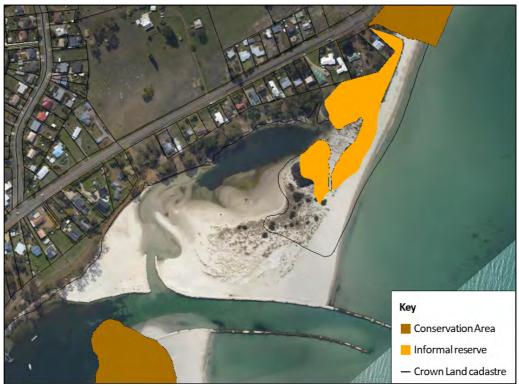
Reservation and cadastral boundaries around the area of the sandbar comprising the Orford IBA (brown areas to the north and south being Raspins Beach and Millingtons Beach Conservation Areas respectively, and the yellow area representing the extent of the informal reserve, noting that not even the Crown Land cadastre (black line) sufficiently covers the extent of the sandbar bird breeding habitat

A small informal reserve (referred to as the Orford Bird Sanctuary) covers part of the sandbar; this location is covered by the *Crown Land Act 1976* (under the administration of DPIPWE). Crown Land extends beyond the informal reserve but does not cover all of the sand bar, with the balance effectively being ungazetted land. In other words, the informal reserve and even the cadastre of Crown Land more broadly fail to capture the full extent of the sandbar habitat that is supporting breeding birds — essentially the fixed boundaries on these jurisdictions are inadequate for a dynamic shifting landscape.

A boundary to protect the important bird area has somewhat been defined on the ground with wire exclusion fencing with accompanying signs noting the presence and breeding of birds. The fencing is limited on the ocean-side due to wave action on Raspins Beach making a fence at the low tide level infeasible; thus, in this area, a sign is present on a post in the middle of the sand that represents the boundary of the informal reserve. The fencing is merely a token barrier and not designed or constructed adequately to function as a genuine exclusion.

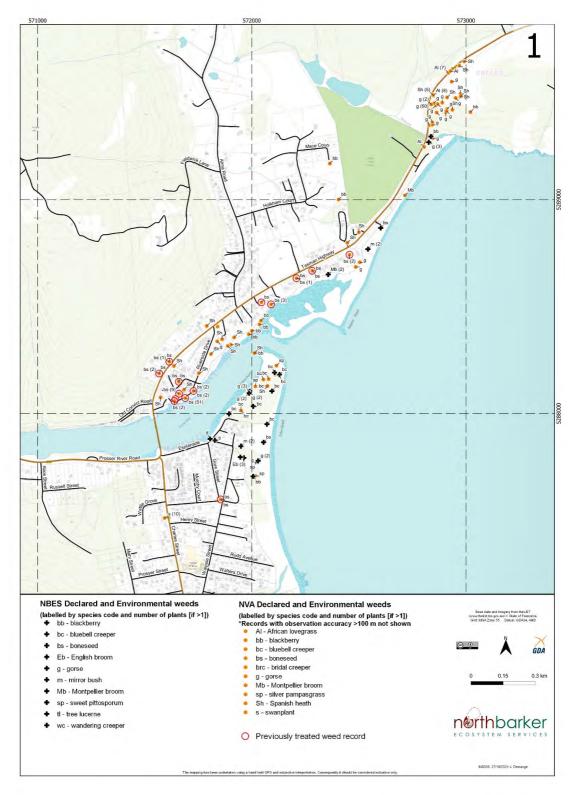
Figure 1: Indicative extent of declared and environmental weeds within the Orford Foreshore Area
